Supporting Documents

ASOS Special Report In-flight Fires

An ASOS Special Report on the History and Horrors of In-Flight Fires.

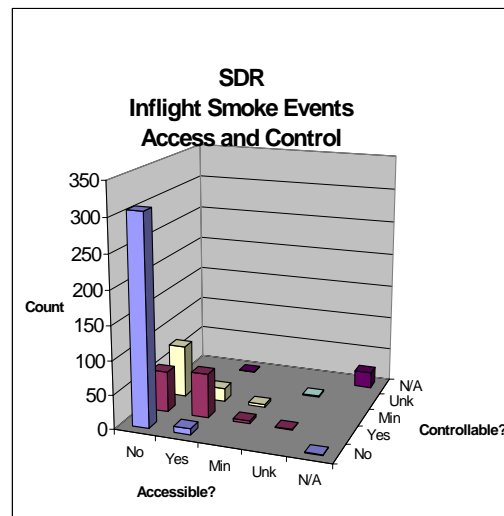
It is significant to note that with current designs and

procedures, the crew had neither access nor control in over half the High Temperature events captured in the database. Control of the event, even at a minimal level, was possible by the crew in less than 40% of the events and access of some kind was possible in less than 20%. Further analysis of the data shows that even the high occurrence items, such as the passenger cabin or cockpit, a majority of those incidents were not accessible by the crew either. This may suggest that from a cost benefit analysis point of view that the best locations for inflight smoke and fire detection and suppression are in the inaccessible areas of the fuselage.
