**ROYAL
AERONAUTICAL
SOCIETY**

SMOKE, FIRE AND FUMES IN TRANSPORT AIRCRAFT

PAST HISTORY, CURRENT RISK AND RECOMMENDED MITIGATIONS

**Second Edition 2013
Part 1: Reference**

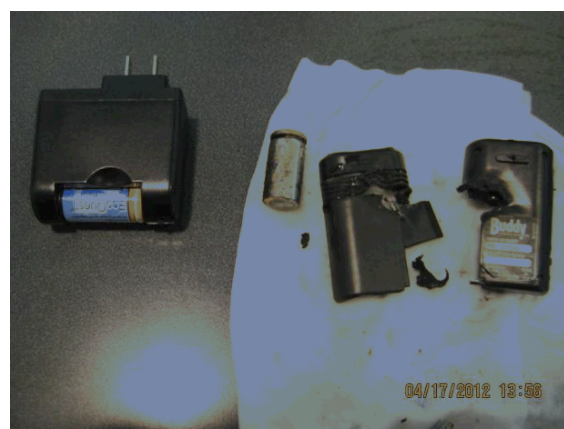
Figure 1. Photo of Mini Air Purifying Device after lithium-ion battery fire on flight from Toronto, Canada, to Minneapolis/Saint Paul, Minnesota, 17 April 2012.

During the in-flight service, the flight attendant noted that the device was on fire on the floor; its battery was burning several feet from the device. Using water from the

On the flight deck, the Captain sensed very strong burning electrical odour coming from the cabin. An emergency was declared and the flight diverted and landed safely at Traverse City, Michigan (Avherald). Li-Ion batteries such as the one described in the incident above do not need to be operating in an active circuit to catch fire and do not require a short to overheat. Incidents like this one are becoming more common as the number of personal electronic devices increase as shown in the FAA office of Security and Hazardous Materials Safety data.
