## Smoke within UPS Flight 006 Report

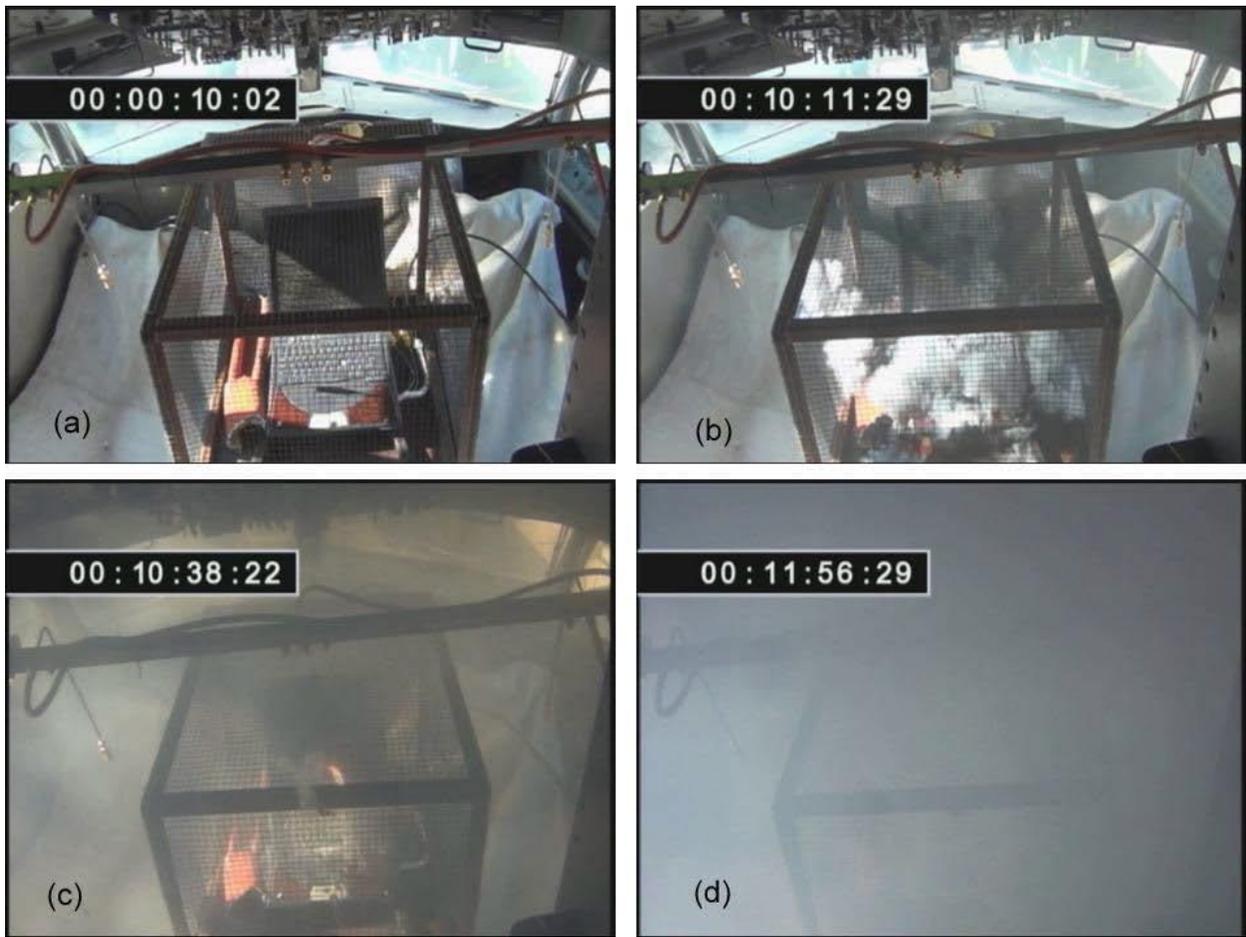
Picture 5 - Loss of pilot vision - ensuring pilot vision in the presences of continuous smoke.

In this accident, the smoke was continuous and of sufficient density and rate of flow to prevent viewing the flight displays, radios panels and the view outside the cockpit.

As an indication of the smoke in the cockpit problem, the pictures below are of an FAA test of an EFB1/Laptop battery fire. The test is a good indication of the lack of visibility encountered when a cockpit is full or filling with smoke. <sup>59</sup>

The visibility should be sufficient to view the attitude indicator or primary flight display and to see outside the aircraft for landing. In addition, it is imperative that the crew be able to view the instruments to navigate and they must be able to see to program the flight management computer and the audio control panels.

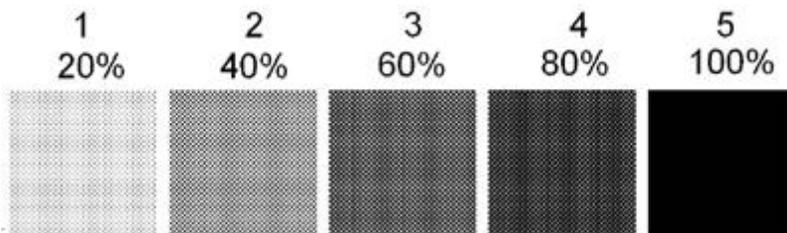
Figure 60 - The Ringelmann Scale: The smoke composition and density scale

In the absence of any recording systems to verify the smoke density it is possible using an established evidence reference data to gauge the smoke density by observing the level of deposited material on surface area or objects ejected from fire zone 1<sup>88</sup> in the debris field, or clear of the fire zones in all debris fields.

Using the Ringelmann scale<sup>89</sup> to compare the deposited residue on the retrieved components from parts of assemblies recovered from the supernumerary area, the Ringelmann scale value were between #4/80% and #5/100%.
